Portage Creek Sediment Remediation Project Kalamazoo, Michigan

Post-Sediment Removal Structure Feature Assessment
Removal Areas SA1-A, SA1-B and SA1-C

F&V Project Number: 809930
October, 2013

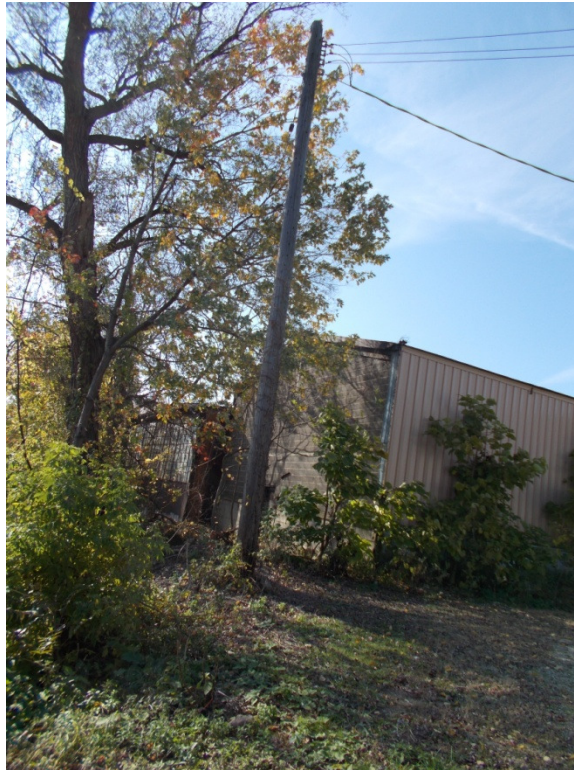
Designation: SA1-A-S01

- The guy wire that had been tangled in woody debris in the channel is now hanging loose on the west bank.
- The structure does not appear to have been impacted during sediment removal.

Pole viewed from the north

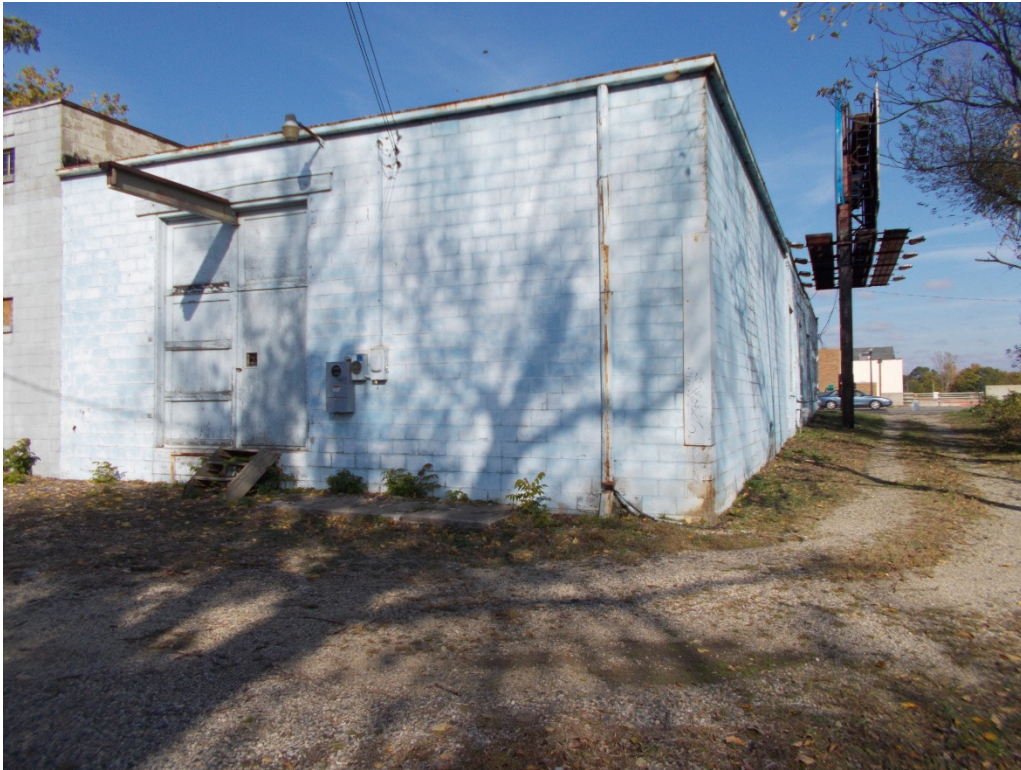
Designation: SA1-A-S02

- Cracking observed does not appear to have changed.
- The structure does not appear to have been impacted during sediment removal.

View of the structure looking north

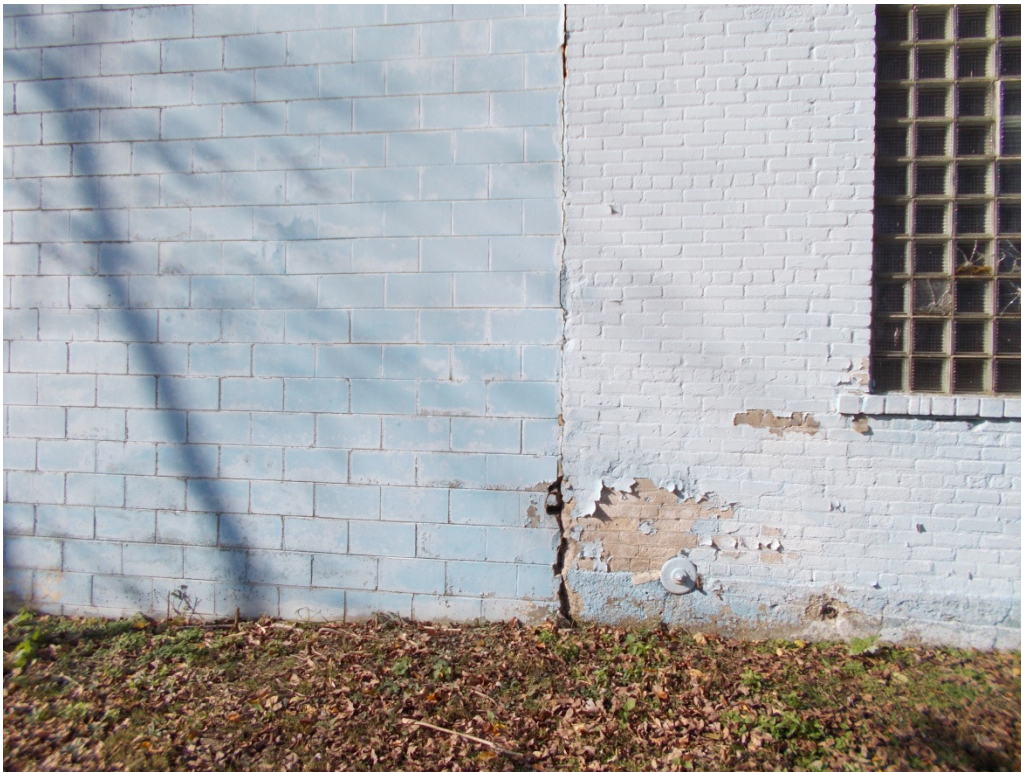
Crack separation at joint between building sections

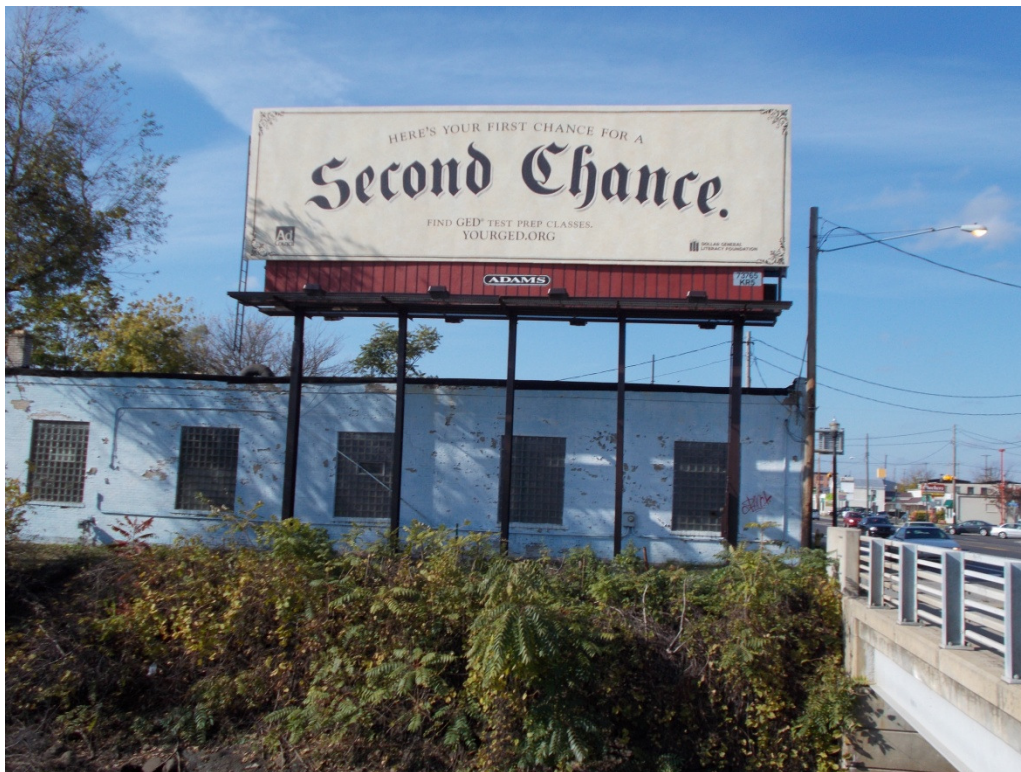
Designation: SA1-A-S03

- The structure does not appear to have been impacted during sediment removal.

View of the structure from the east bank

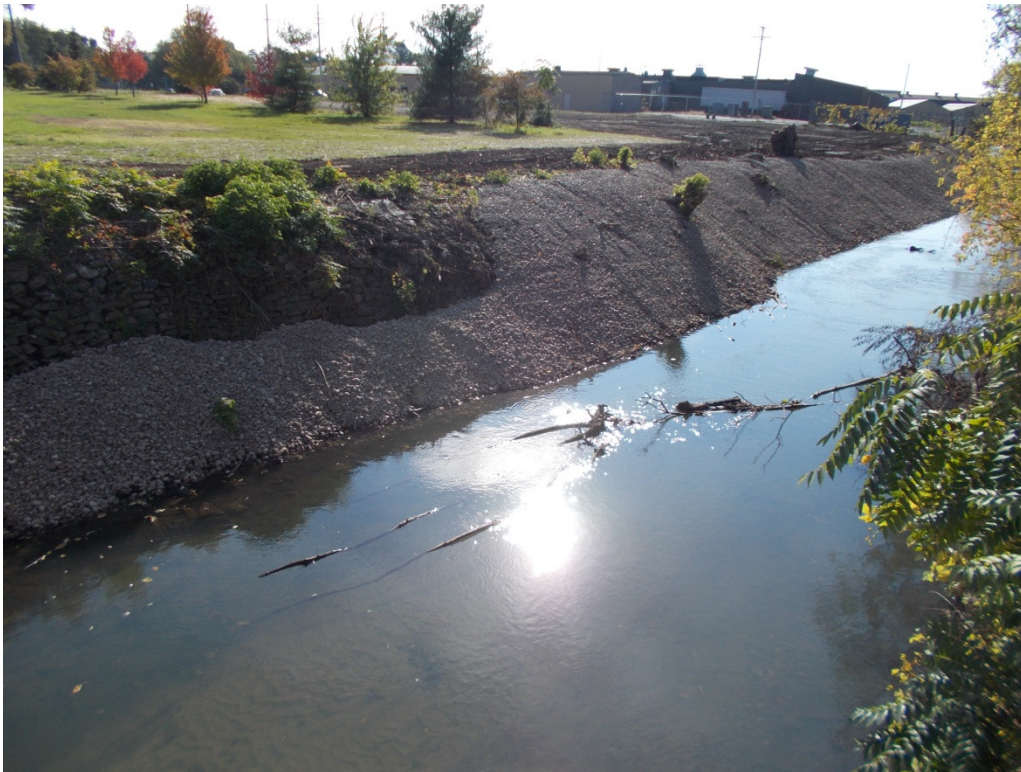
Designation: SA1-A-S04

- The structure has been removed and bank restored with riprap.

View of the east bank where SA1-A-S04 was previously located.

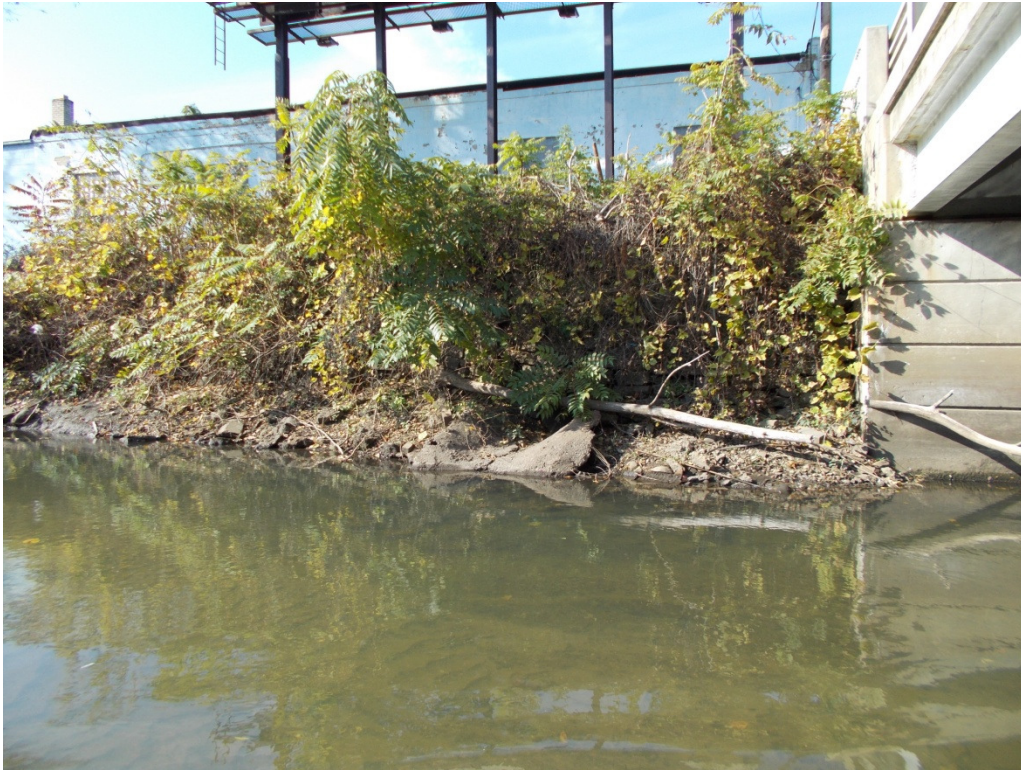
Designation: SA1-A-S05

- A concrete outlet through the wall was obscured by high water during the Pre-Sediment Removal Structure Feature Assessment, however, it does not appear to have been impacted by the work.
- The structure does not appear to have been impacted during sediment removal.

View of structure from the channel

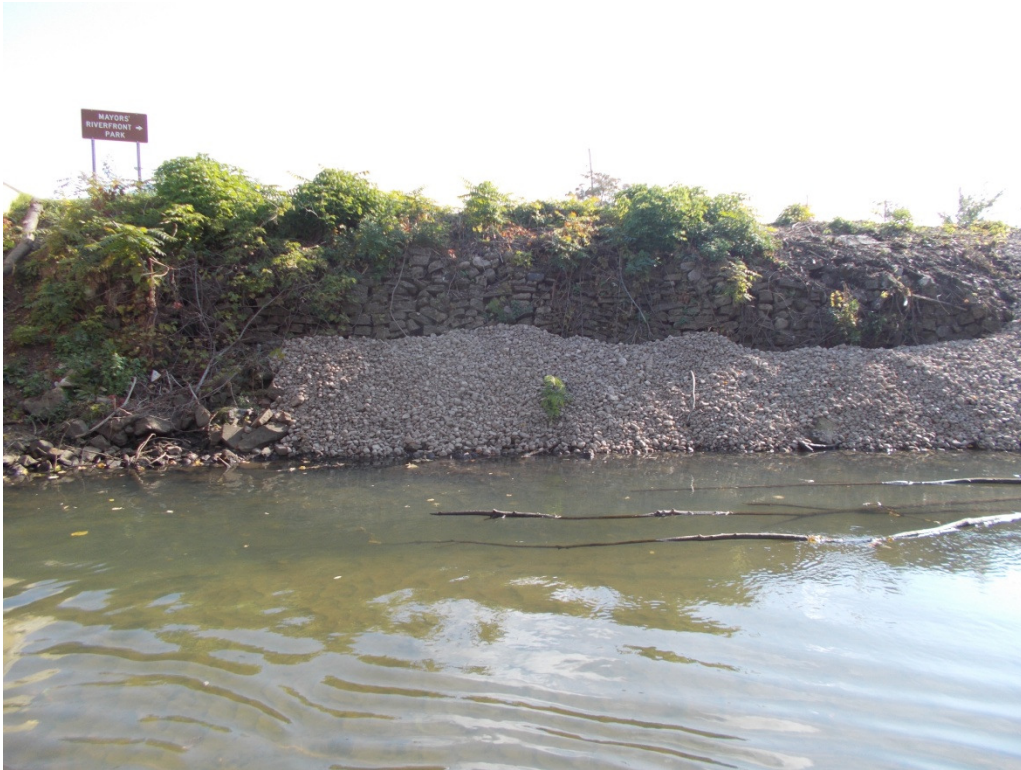
Designation: SA1-A-S06

- Cobble riprap has been placed in front of the wall along the water's edge.
- The structure does not appear to have been impacted during sediment removal.

View of structure from the channel

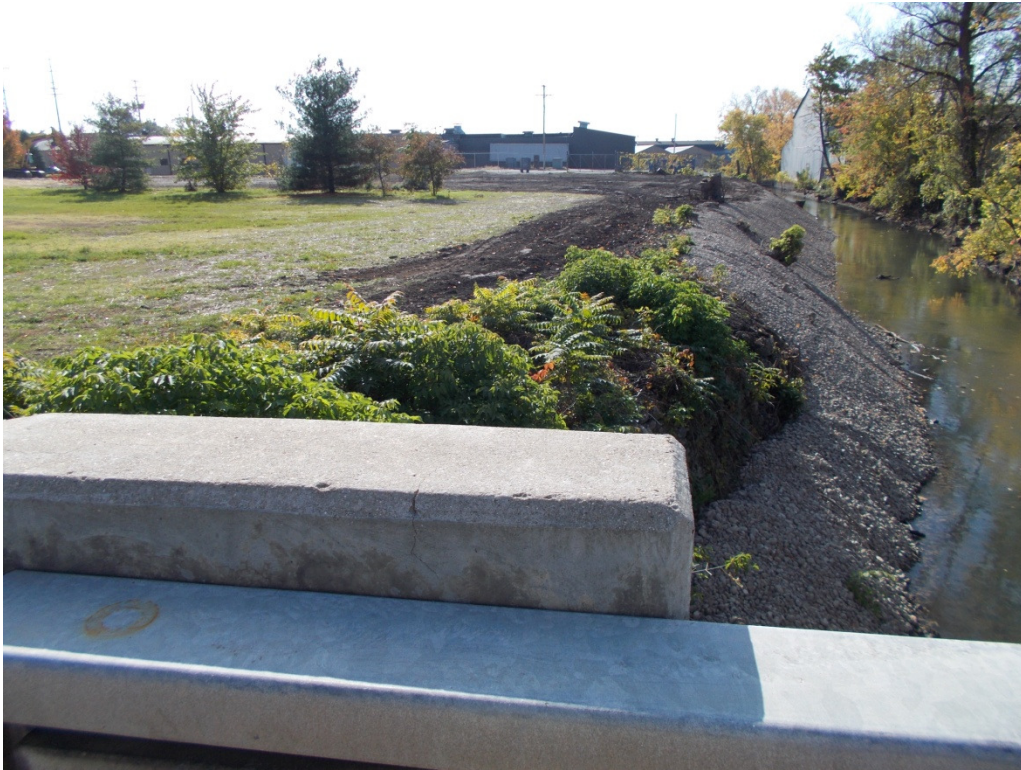
- Restoration is ongoing in the southeast quadrant.
- The northwest quadrant has been cleared and restored with riprap.
- The structure does not appear to have been impacted during sediment removal.

Ongoing restoration in the southeast quadrant

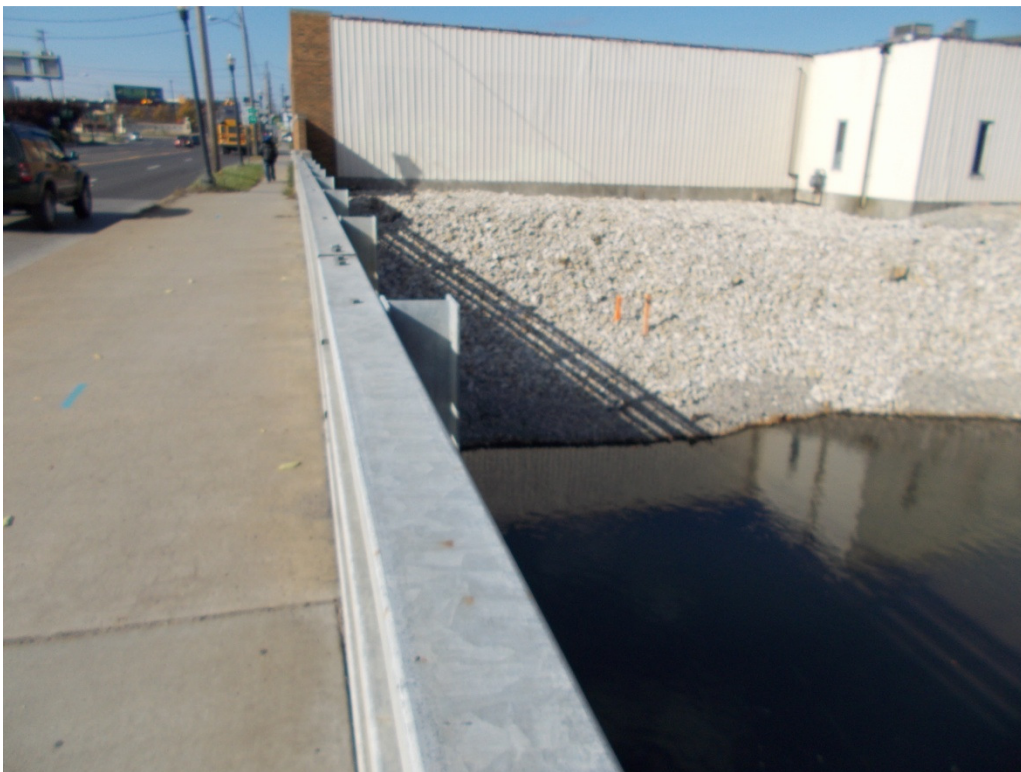
Riprap on northwest bank

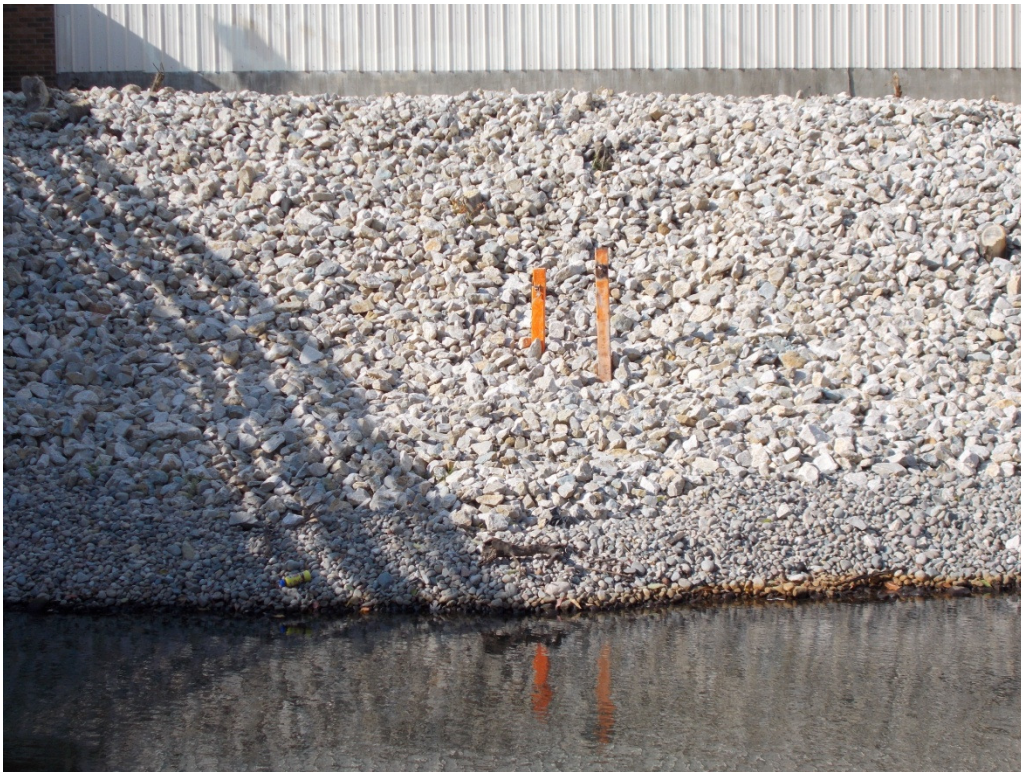
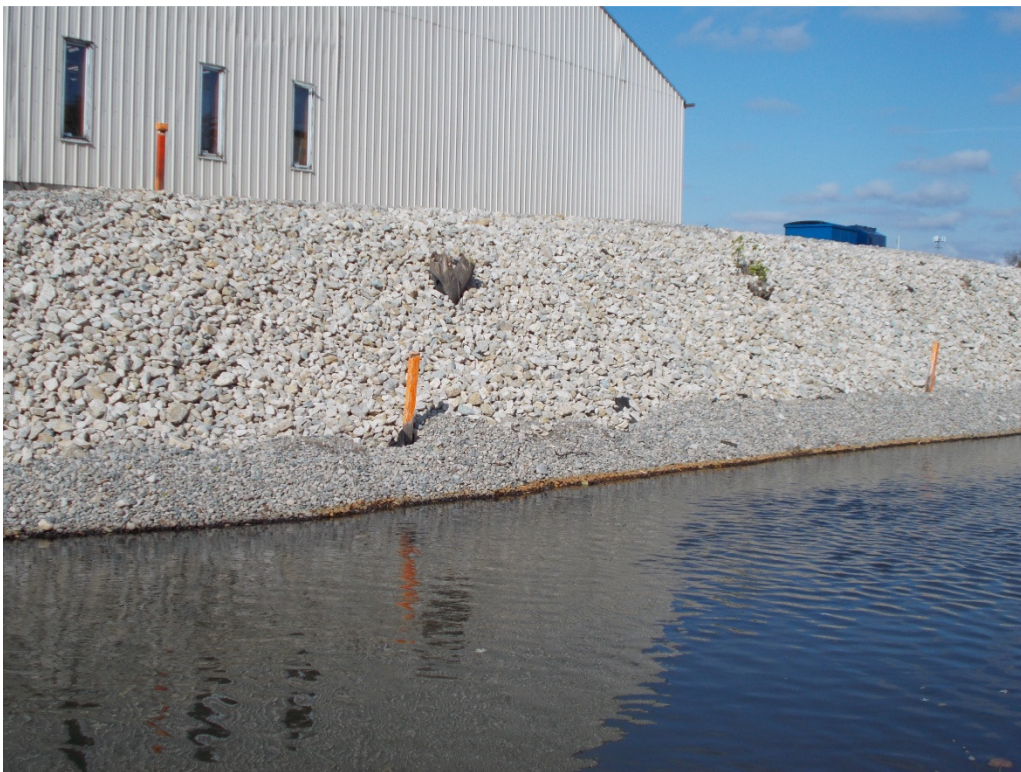
Designation: SA1-A-S09

- The bank has been cleared and the area restored with riprap.
- The monitoring wells do not appear to have been impacted during sediment removal.

View of structures from the channel

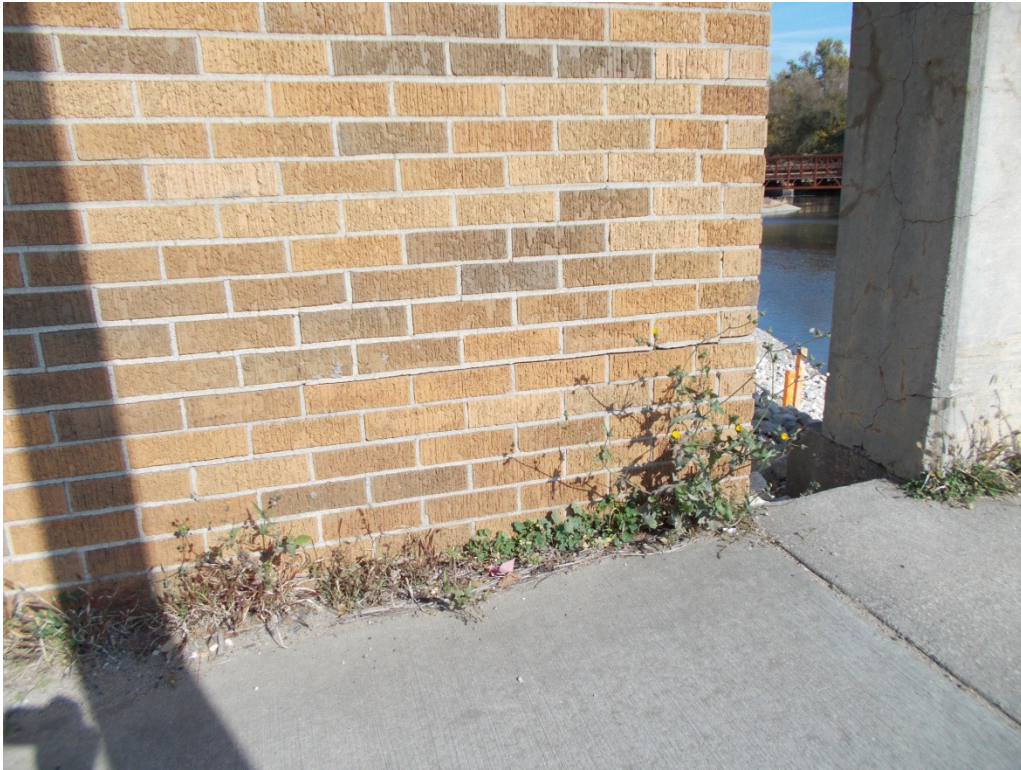
- Cracking in the brick extension wall appears to be unchanged.
- The bank along the structure has been cleared and restored with riprap.
- The structure does not appear to have been impacted during sediment removal.

Cracking in brick extension wall looking north

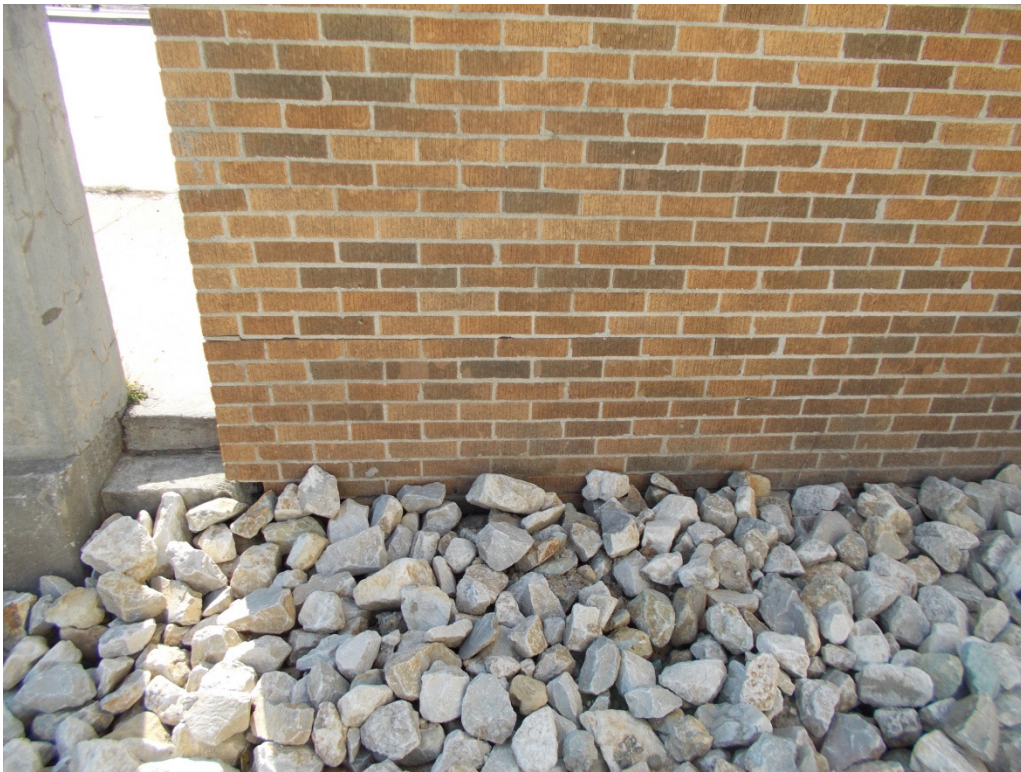
Cracking in brick extension wall looking south

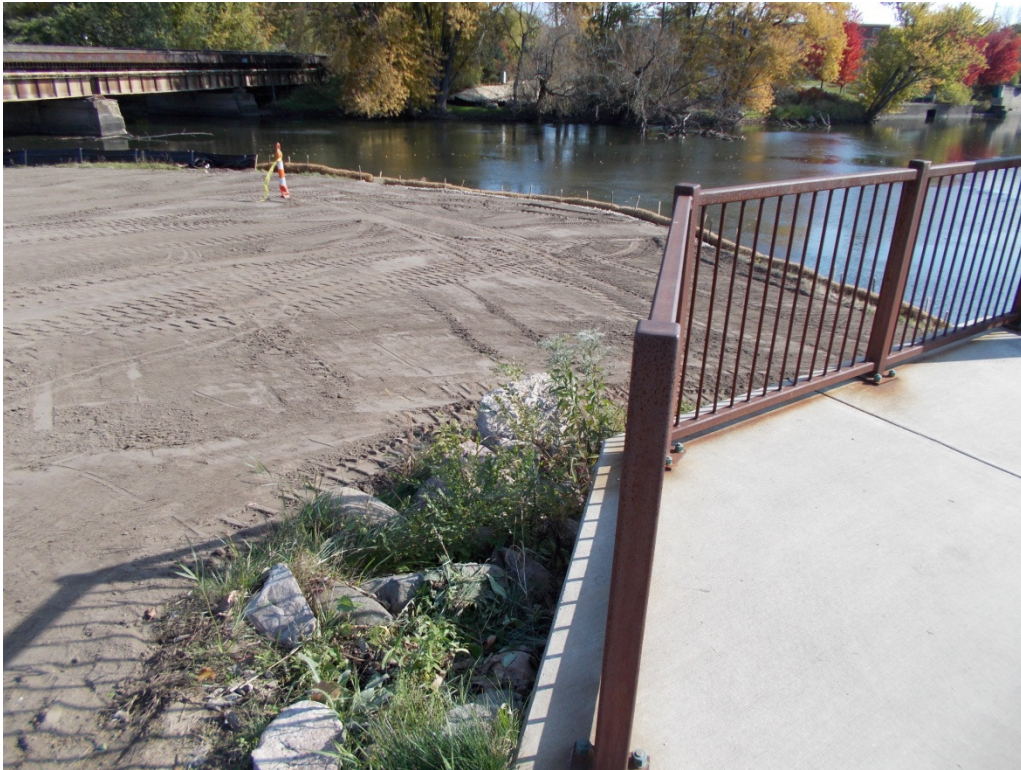
- Trees and other landscaping in the northwest quadrant have been removed.
- Restoration is ongoing in the northwest quadrant.
- The monitoring well in the northwest quadrant appears to have been preserved.
- Repair of the split rail fence in the northwest was nearly complete at the time of evaluation.
- There are a number of cracked flags of concrete sidewalk in the southeast quadrant. They appear to be marked for replacement along with extension of the walk to the east.
- The structure itself does not appear to have been impacted during sediment removal.

Ongoing restoration in the northwest, monitoring well demarked with channelizing device

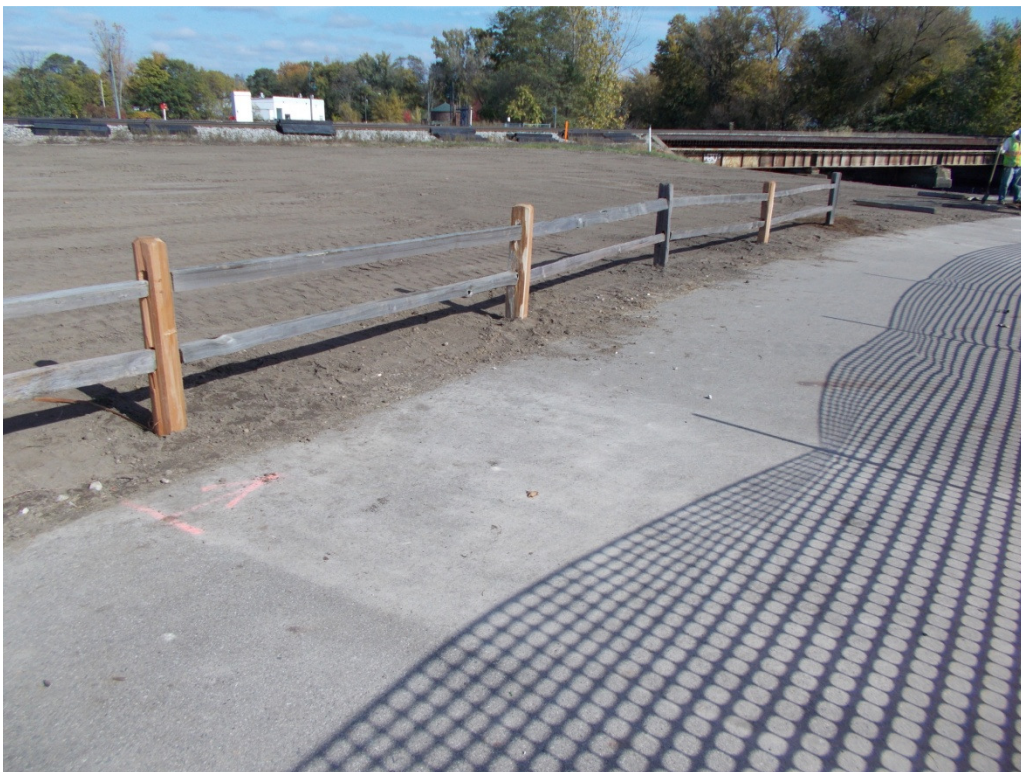
Ongoing replacement of split rail fence in northwest

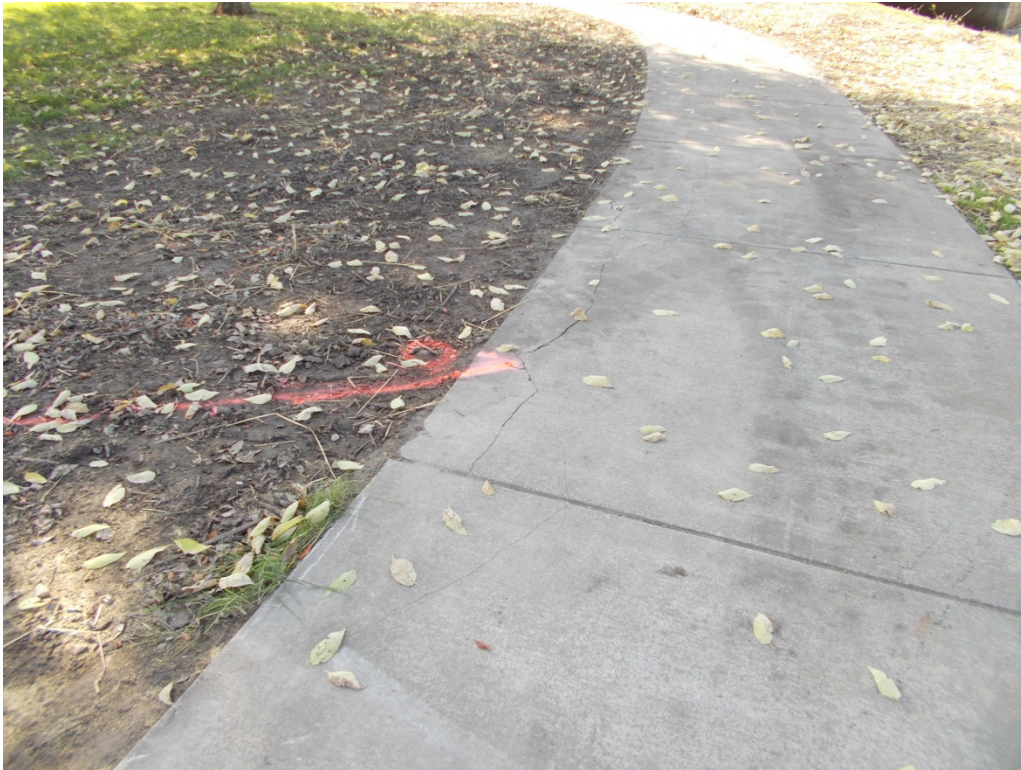
Cracked sidewalk in the southeast quadrant

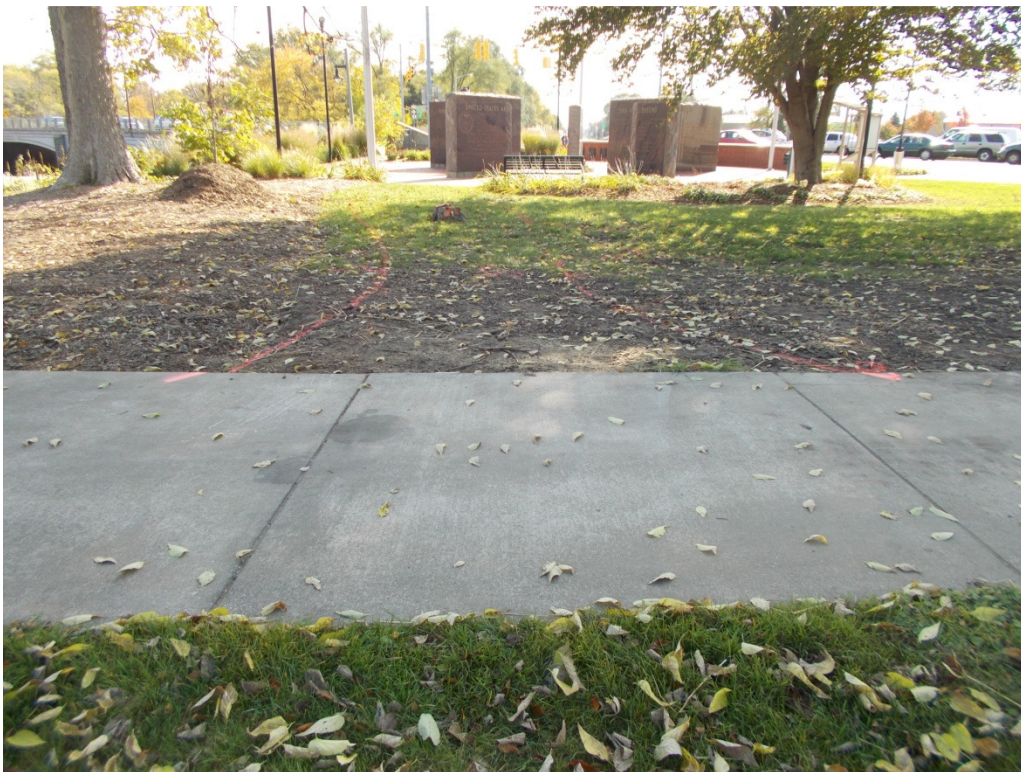
Cracked sidewalk in the southeast quadrant

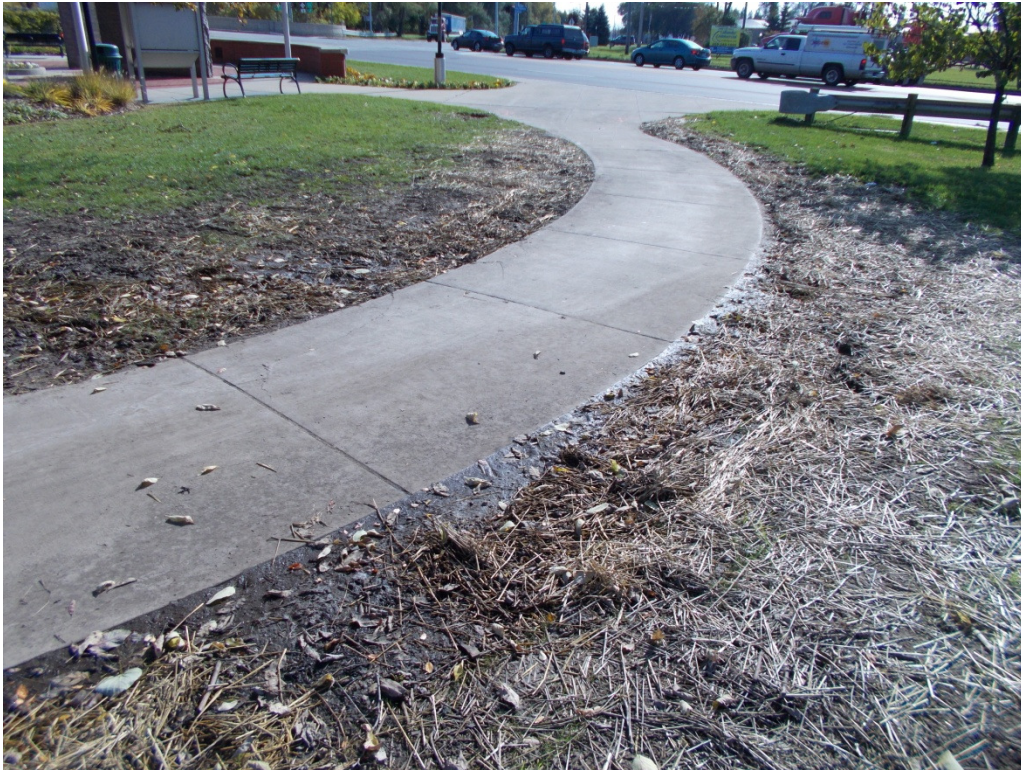
Cracked sidewalk in the southeast quadrant

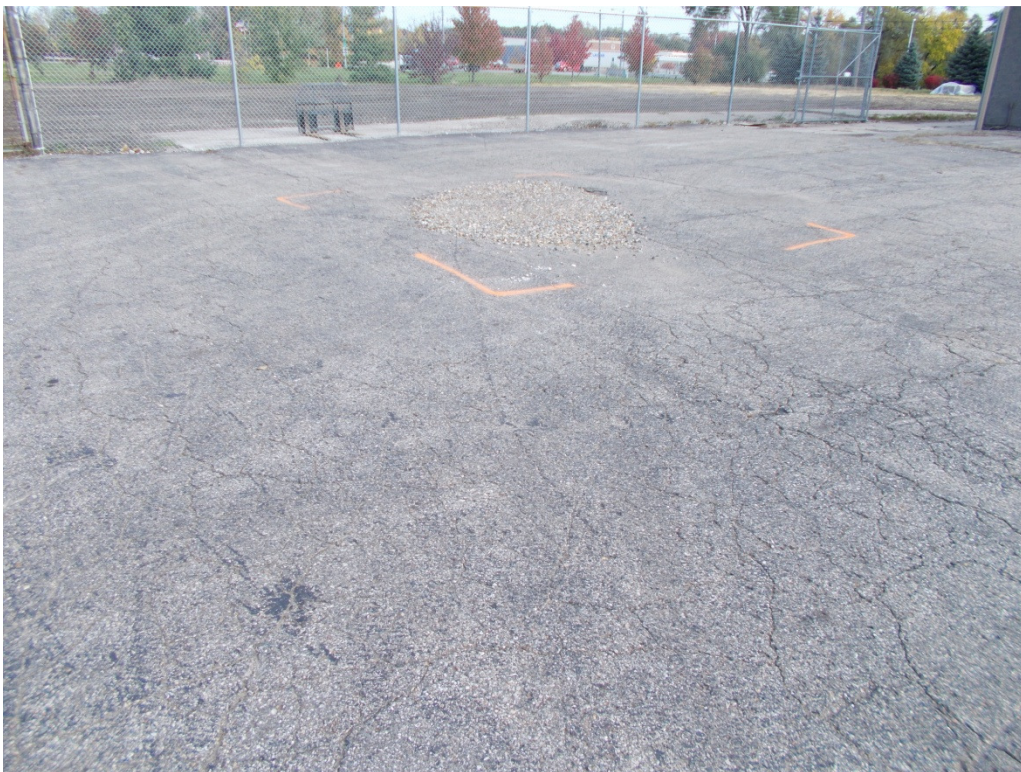
- Generally, the structure does not appear to have been impacted during sediment removal.
- Loose/failing concrete appears to have been removed from the dumpster parking block.
- One isolated area of failed pavement in the northeast appears to be marked for replacement.

Isolated pavement failure apparently marked for replacement

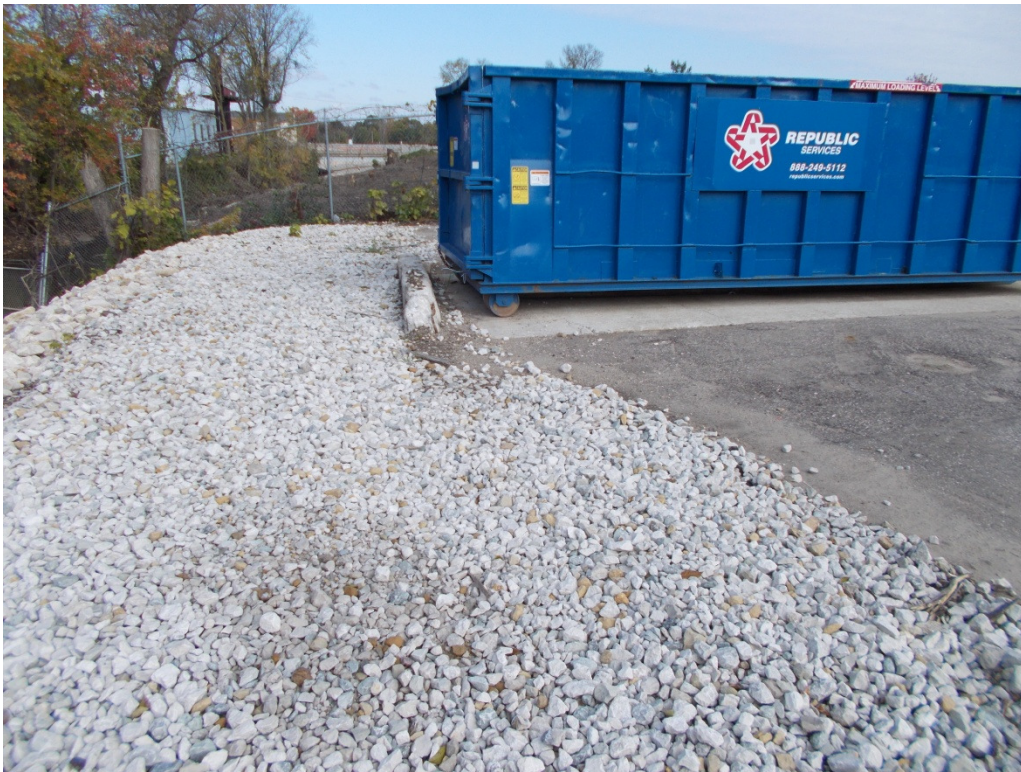
Dumpster pad and parking block

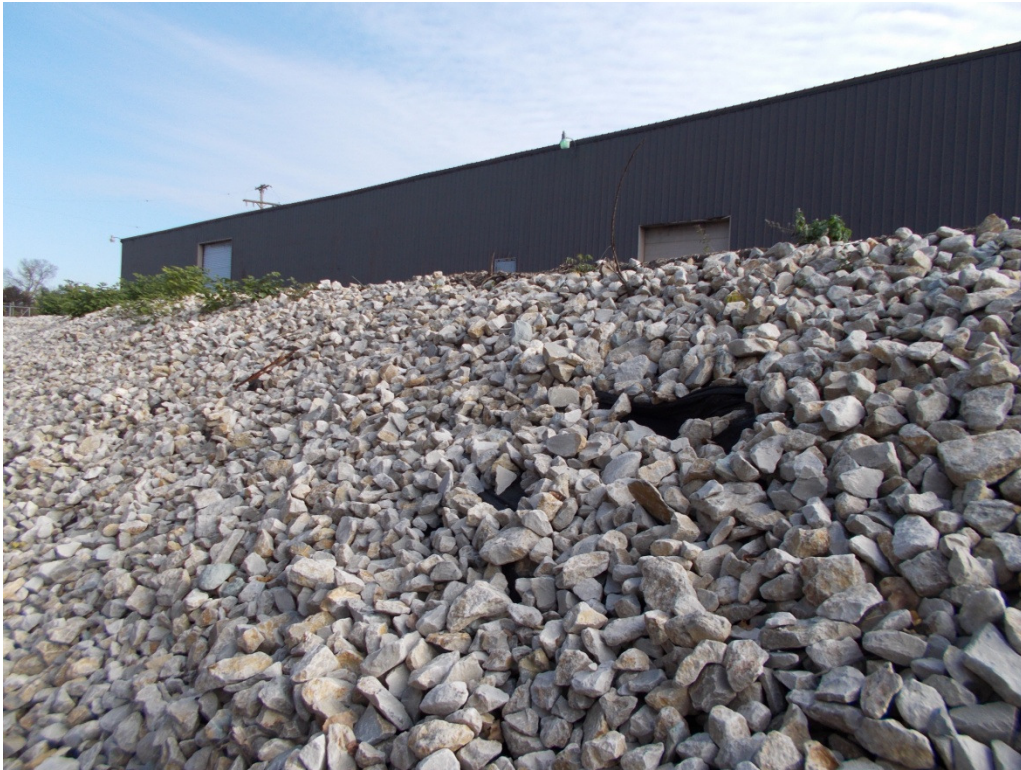
Designation: SA1-B-S02

- The bank around the outlet has been restored with riprap.
- The outlet appears to have been removed or covered with geotextile fabric. If it is still operational, the geotextile fabric should be trimmed out around the outlet.

View of the bank around the previous location of SA1-B-S02

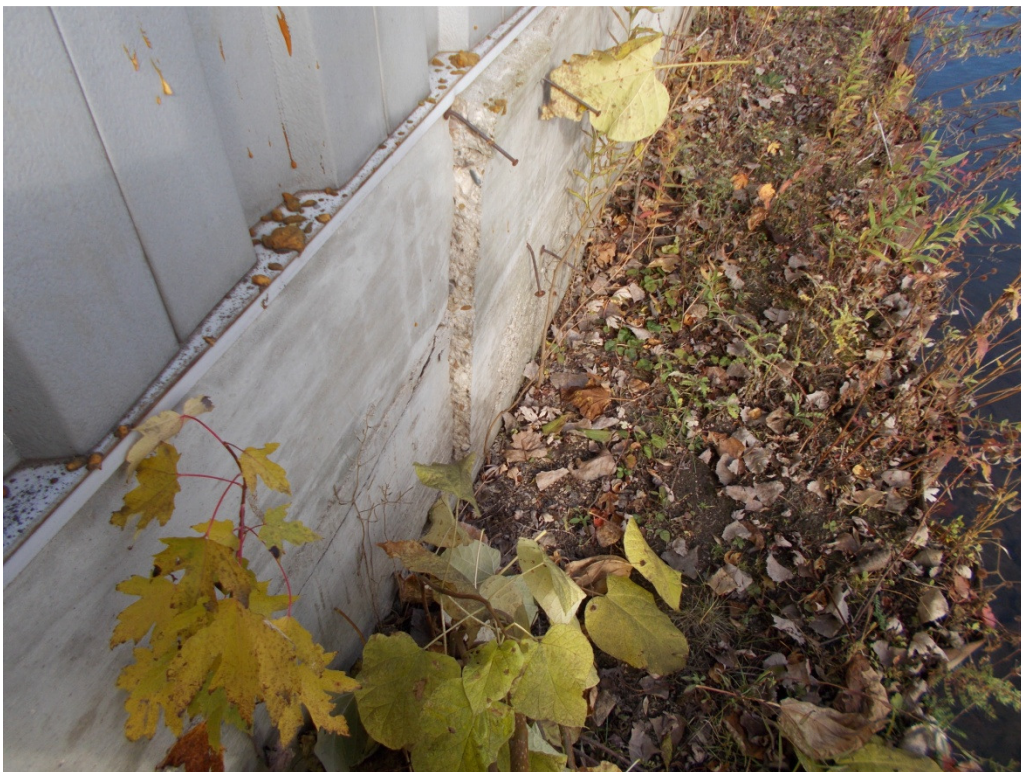
- Cracking and undermining observed does not appear to have changed.
- The structure does not appear to have been impacted during sediment removal.

Critical cracking in concrete foundation wall

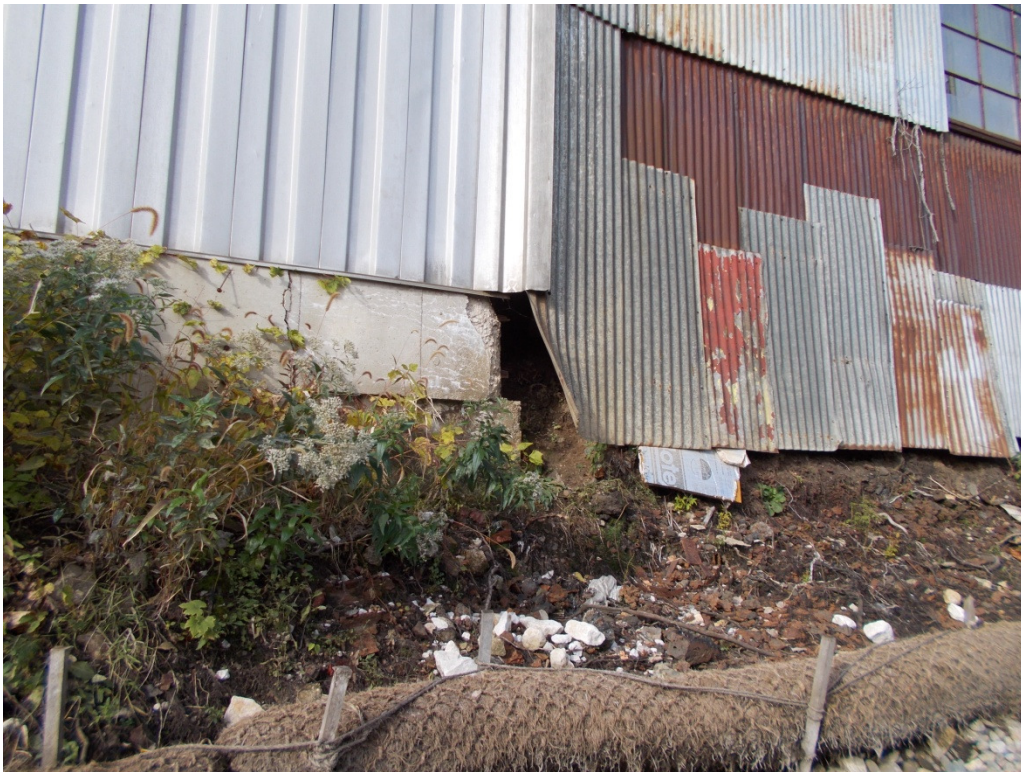
Failed corrugated siding and building transition

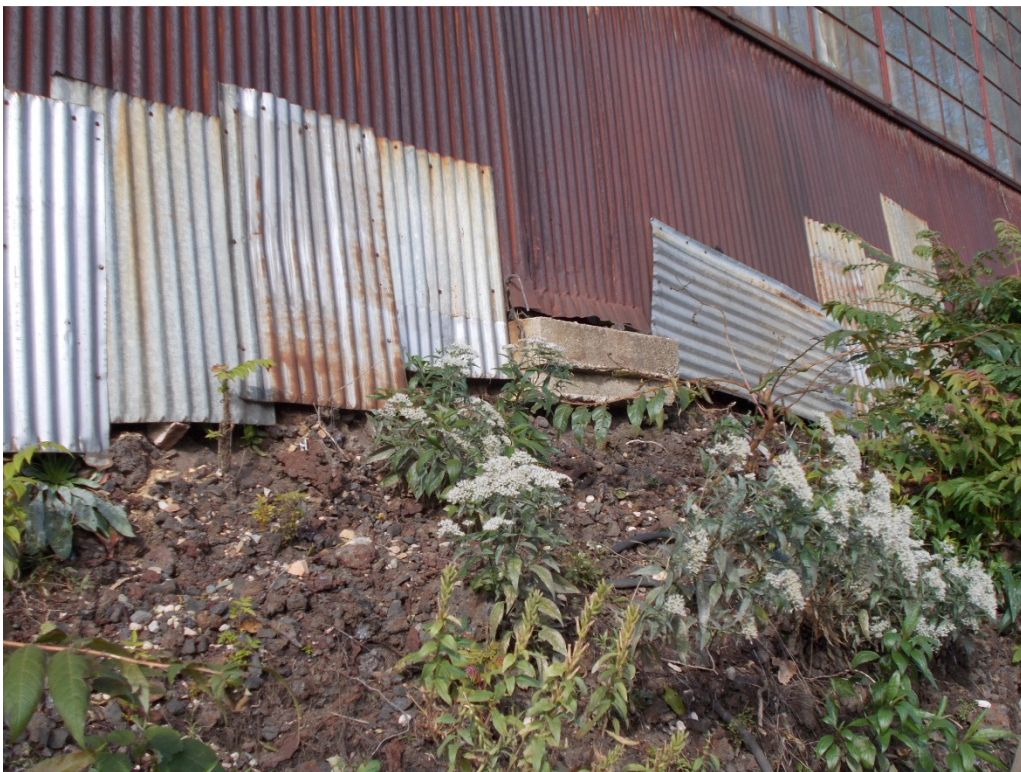
Undermined column footing

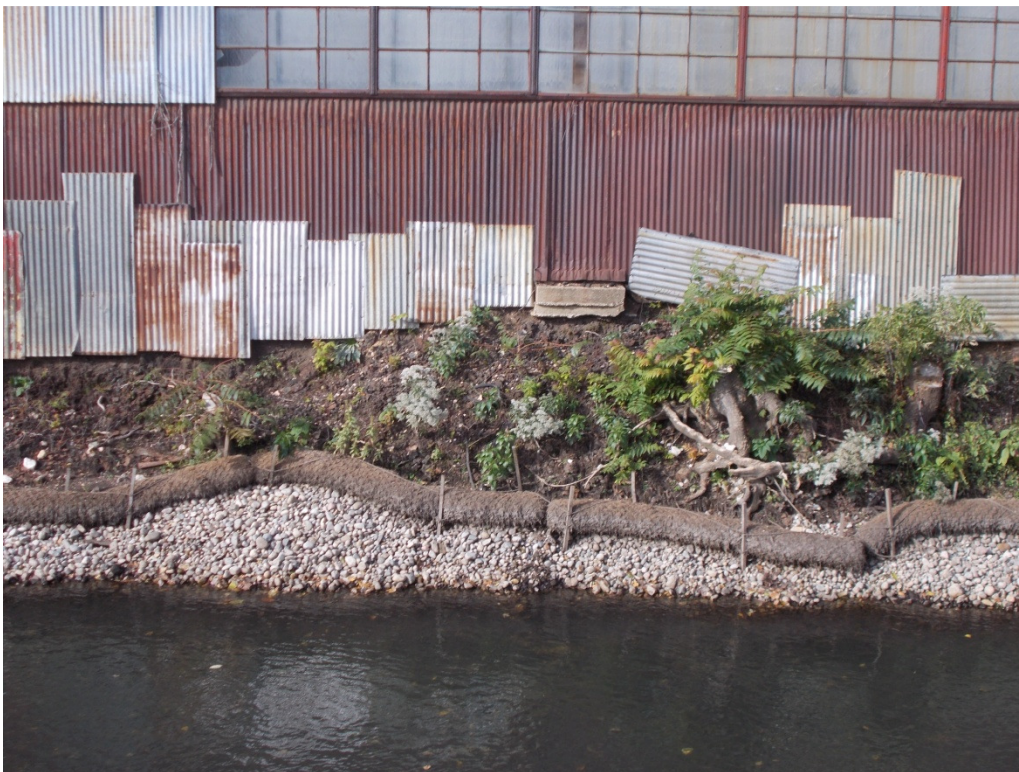
View of undermined column footing from east bank

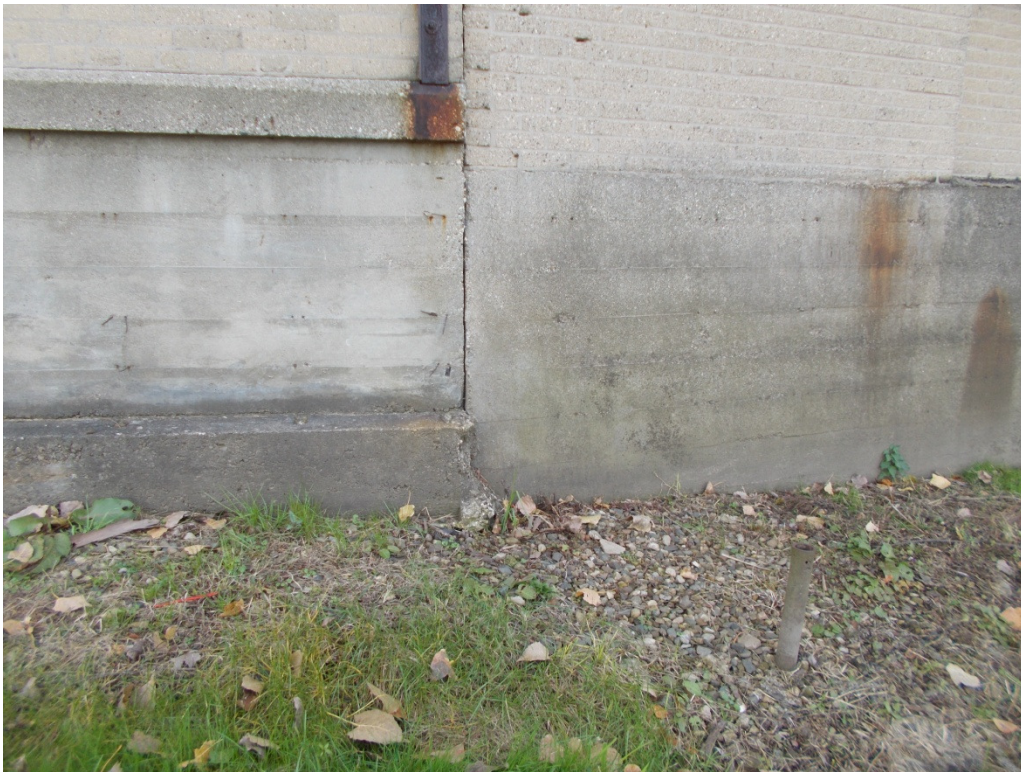
Separation between sections of foundation wall appears unchanged

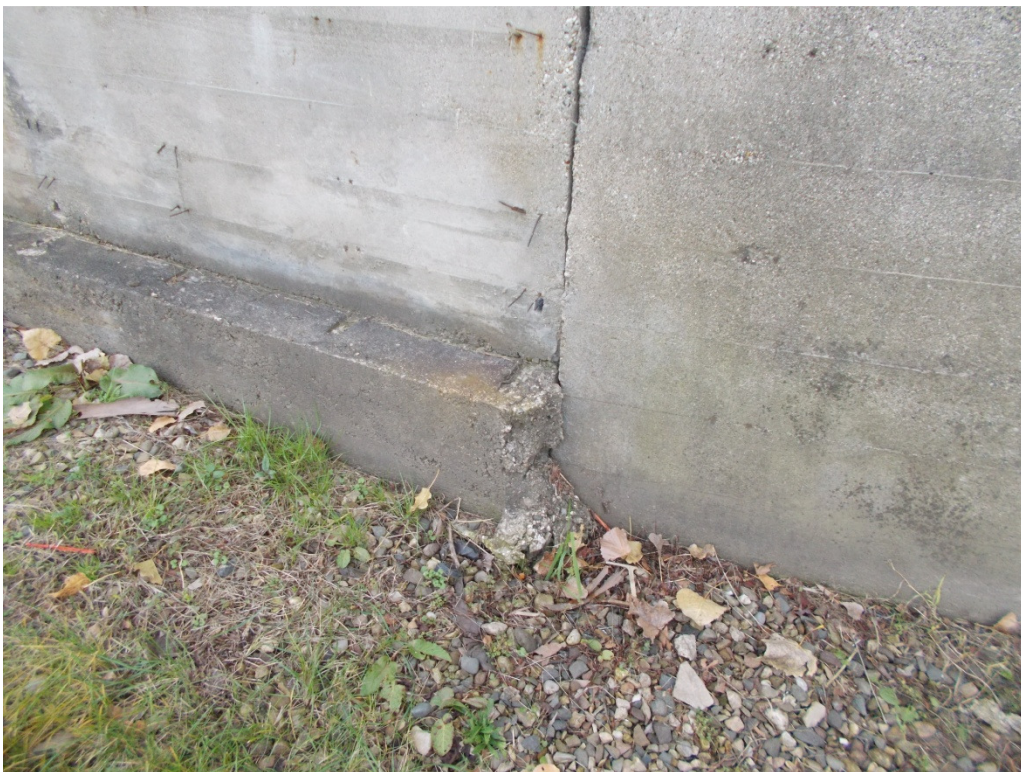
Exposed footing appears unchanged

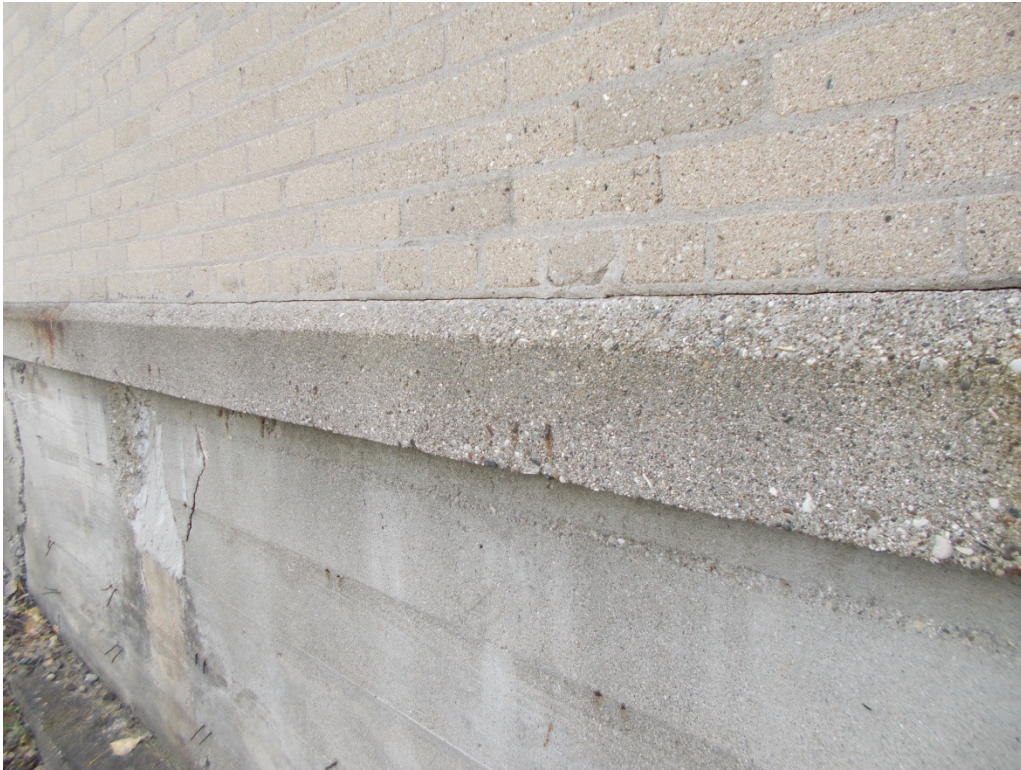
Cracking in wall appears unchanged
